# INFRASTRUCTURE ASSESSMENT AND 10-YEAR CAPITAL PLAN – FINAL REPORT

March 2, 2020 Project Number 5454-006-00 #101, 10630-172 Street Edmonton, AB T5S 1H8 Phone: 780-486-2000

Town of Westlock Infrastructure Assessment and 10-Year Capital Plan – Final Report Re:

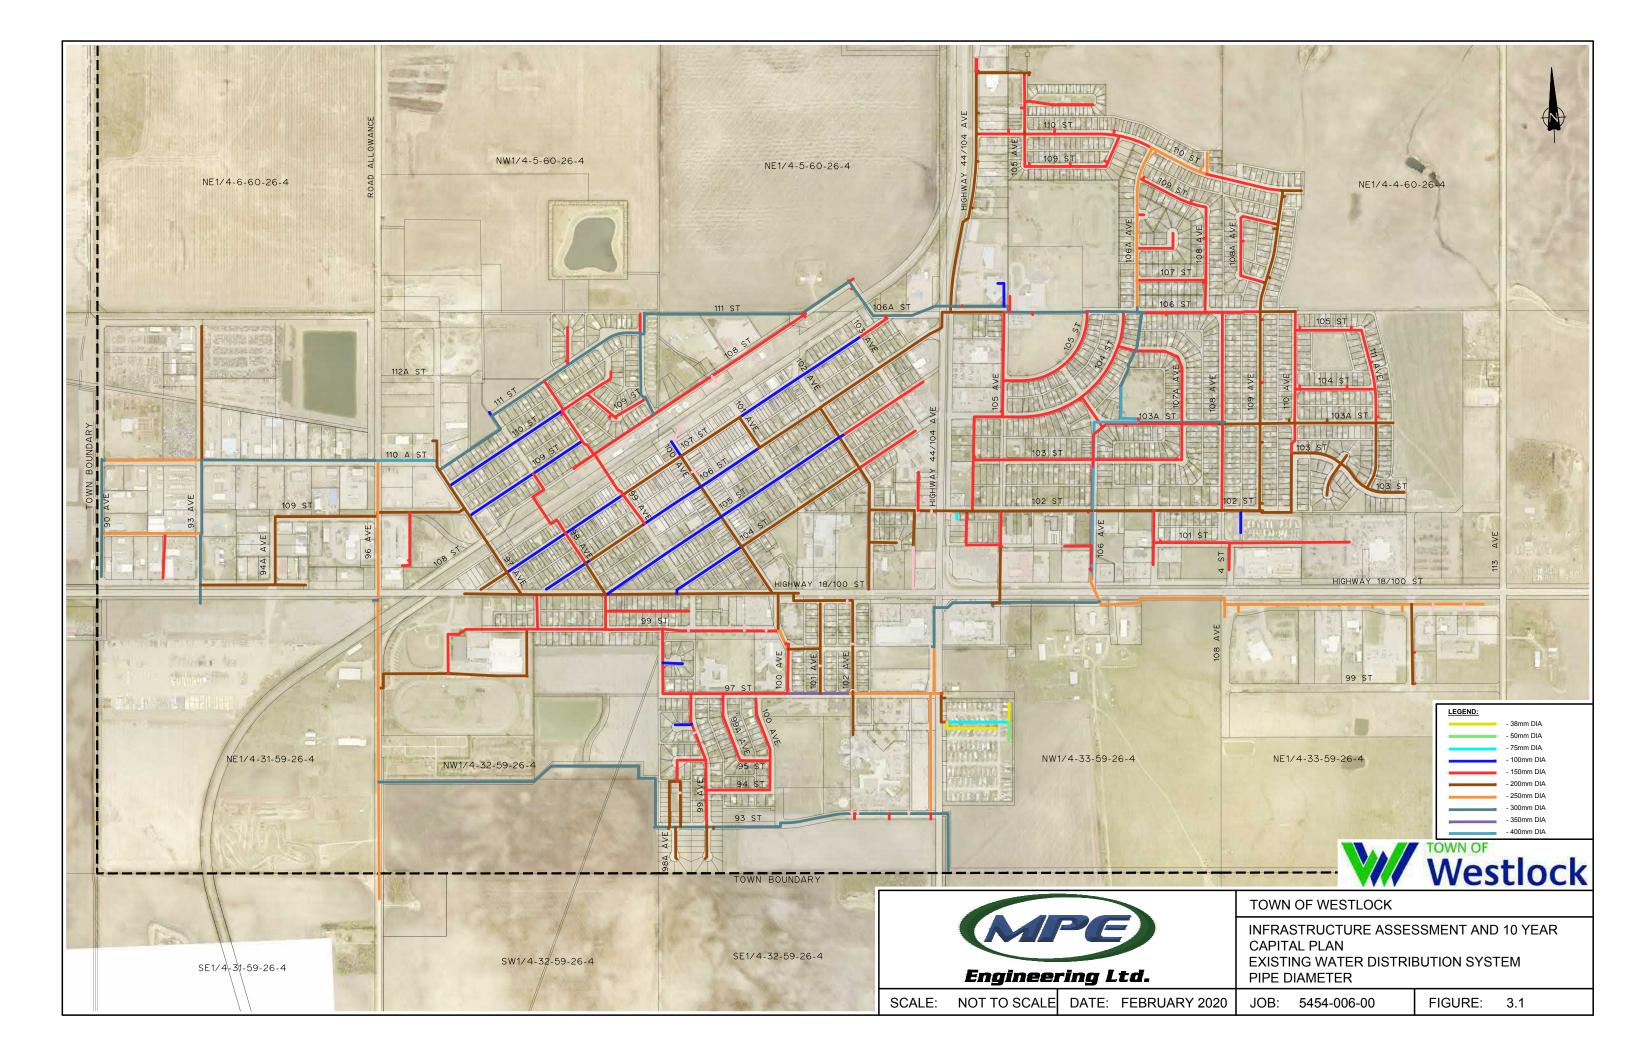
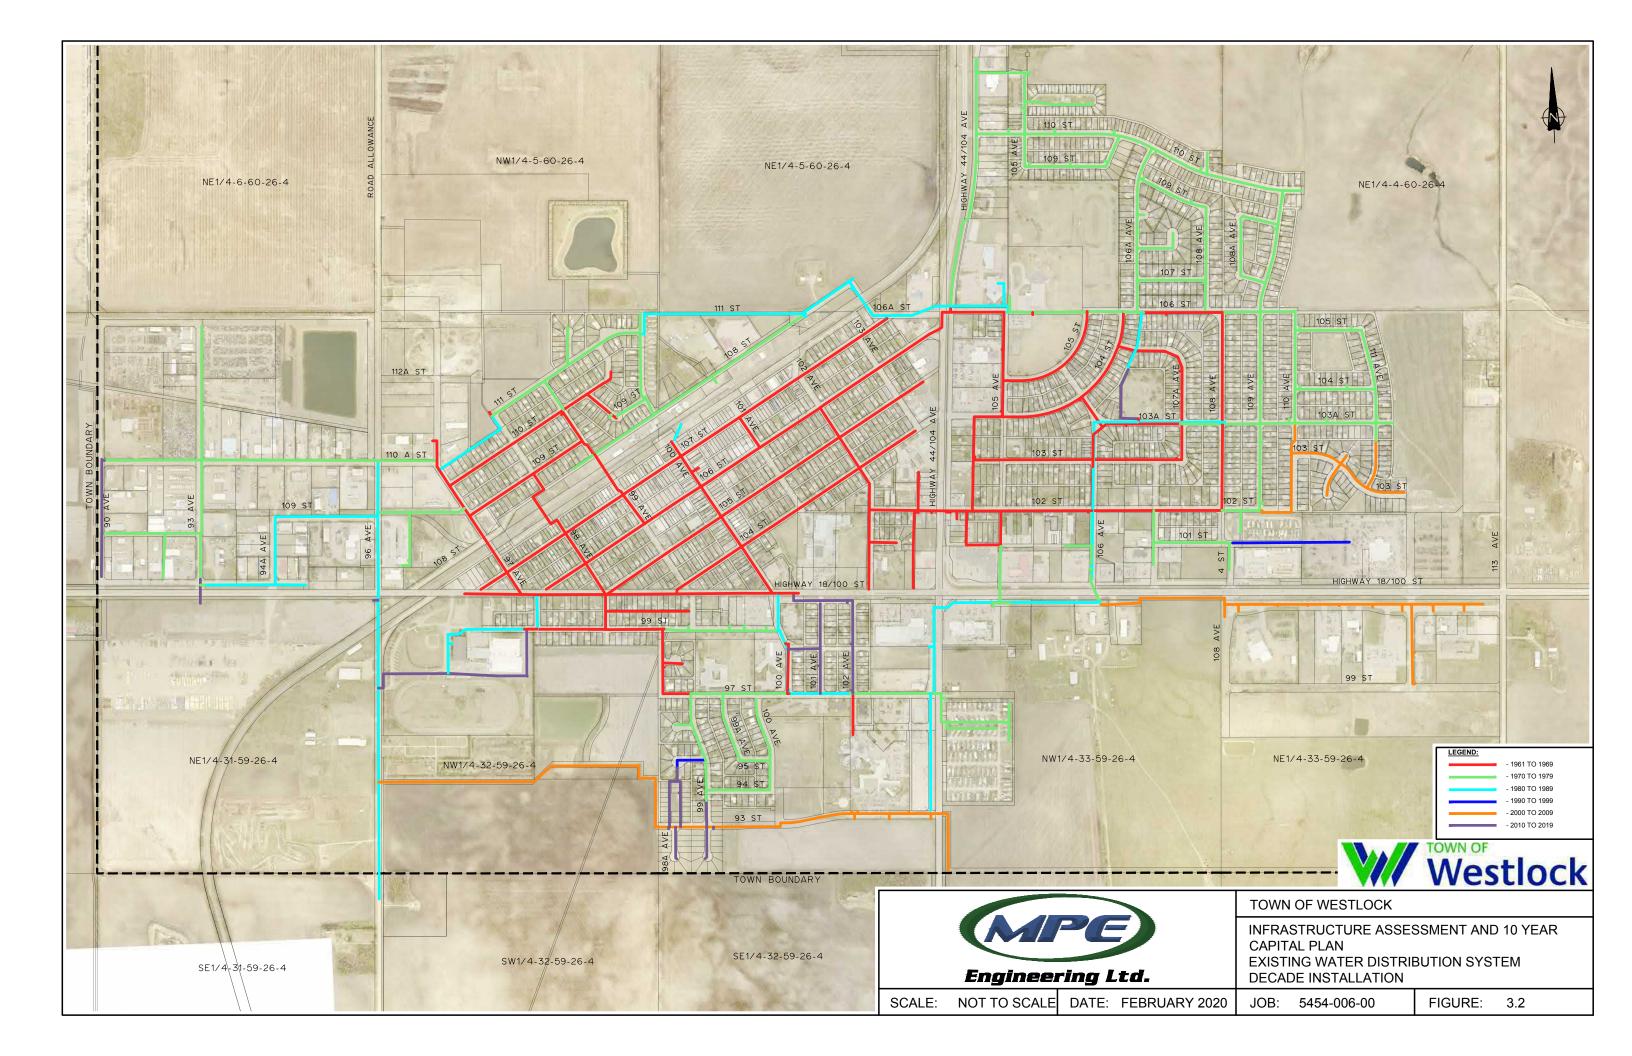
Figure 3.1 shows that many watermains in the Town are 75 mm, 100 mm and 150 mm in diameter. The *Town of Westlock, Procedures and Design Standards for Development, October 2009* (Design Standards), states that the minimum size of water distribution mains should be:

As the 75 mm, 100 mm and 150 mm diameter watermains are replaced, MPE recommends that the Town replace them with an increased size based on the requirements from the Design Standards above.

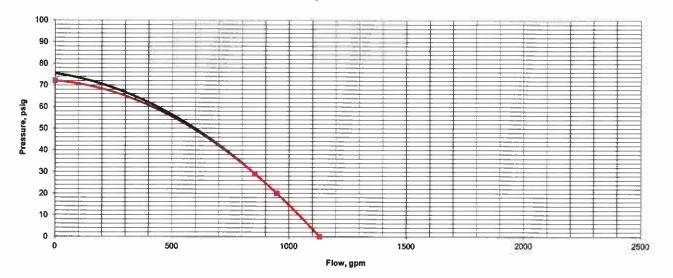
- □ The field test at Test Location #2 along 109 Street indicated 283 kPa (41 psi) lower pressure in the field compared with the model. This suggests a possible restriction in the pipe such as a partially closed upstream valve and/or severe tuberculation in the 100 mm main installed between 1961 and 1969. Regardless of the possibility of tuberculation, the Town should upsize the 100 mm diameter mains to 200 mm in diameter, as recommended in Section 3.5.

X Tauly v	Water FI	ow Test	Report			Na T
LOCATION/HYDRANT#	#2 (Hydrant # 26) 97 ave	& 109 st	200-249	Property and a	Di .	DATE:	18/05/2019
TEST BY:	S. Koflick	пправодал	100	TIME OF DAY:	1000hrs		
WATER SUPPLIED BY:	Town of Westlock		Lance Control		SOLIS A SERVICE	e dinaket	E02) (S3),
PURPOSE OF TEST:	Water Model Calibration			even anna a dinamen			
			DATA				
FLOW HYDRANT(S)		A1		A2		A3	
	SIZE OPENING:	2.5		2.5	_	2.5	_
	COEFFICIENT:	0.9	0.0	0.9		0.9	
	PITOT READING:	26	-	0	複	0	0
	GPM:	856		0	_	0	
TOTAL FLOW DURING 1	EST:	856	GPM			47	
TOWER LEVEL @ TIME	OF TEST:			TOWER LOW	0		
STATIC READING:	72	PSI		RESIDUAL;	29	PSI	
ADJ. STATIC:	72	_PSI		AJD. RESIDUAL:	29	_PSI	
ADJ. FLOW:	AT 20 PSI RESIDUAL	948	GPM		AT 0 PSI	1130	GPM
