TOWN OF WESTLOCK

SANITARY SEWER MASTER PLAN UPDATE

Date: January 31, 2020
Project: 5454-009-00

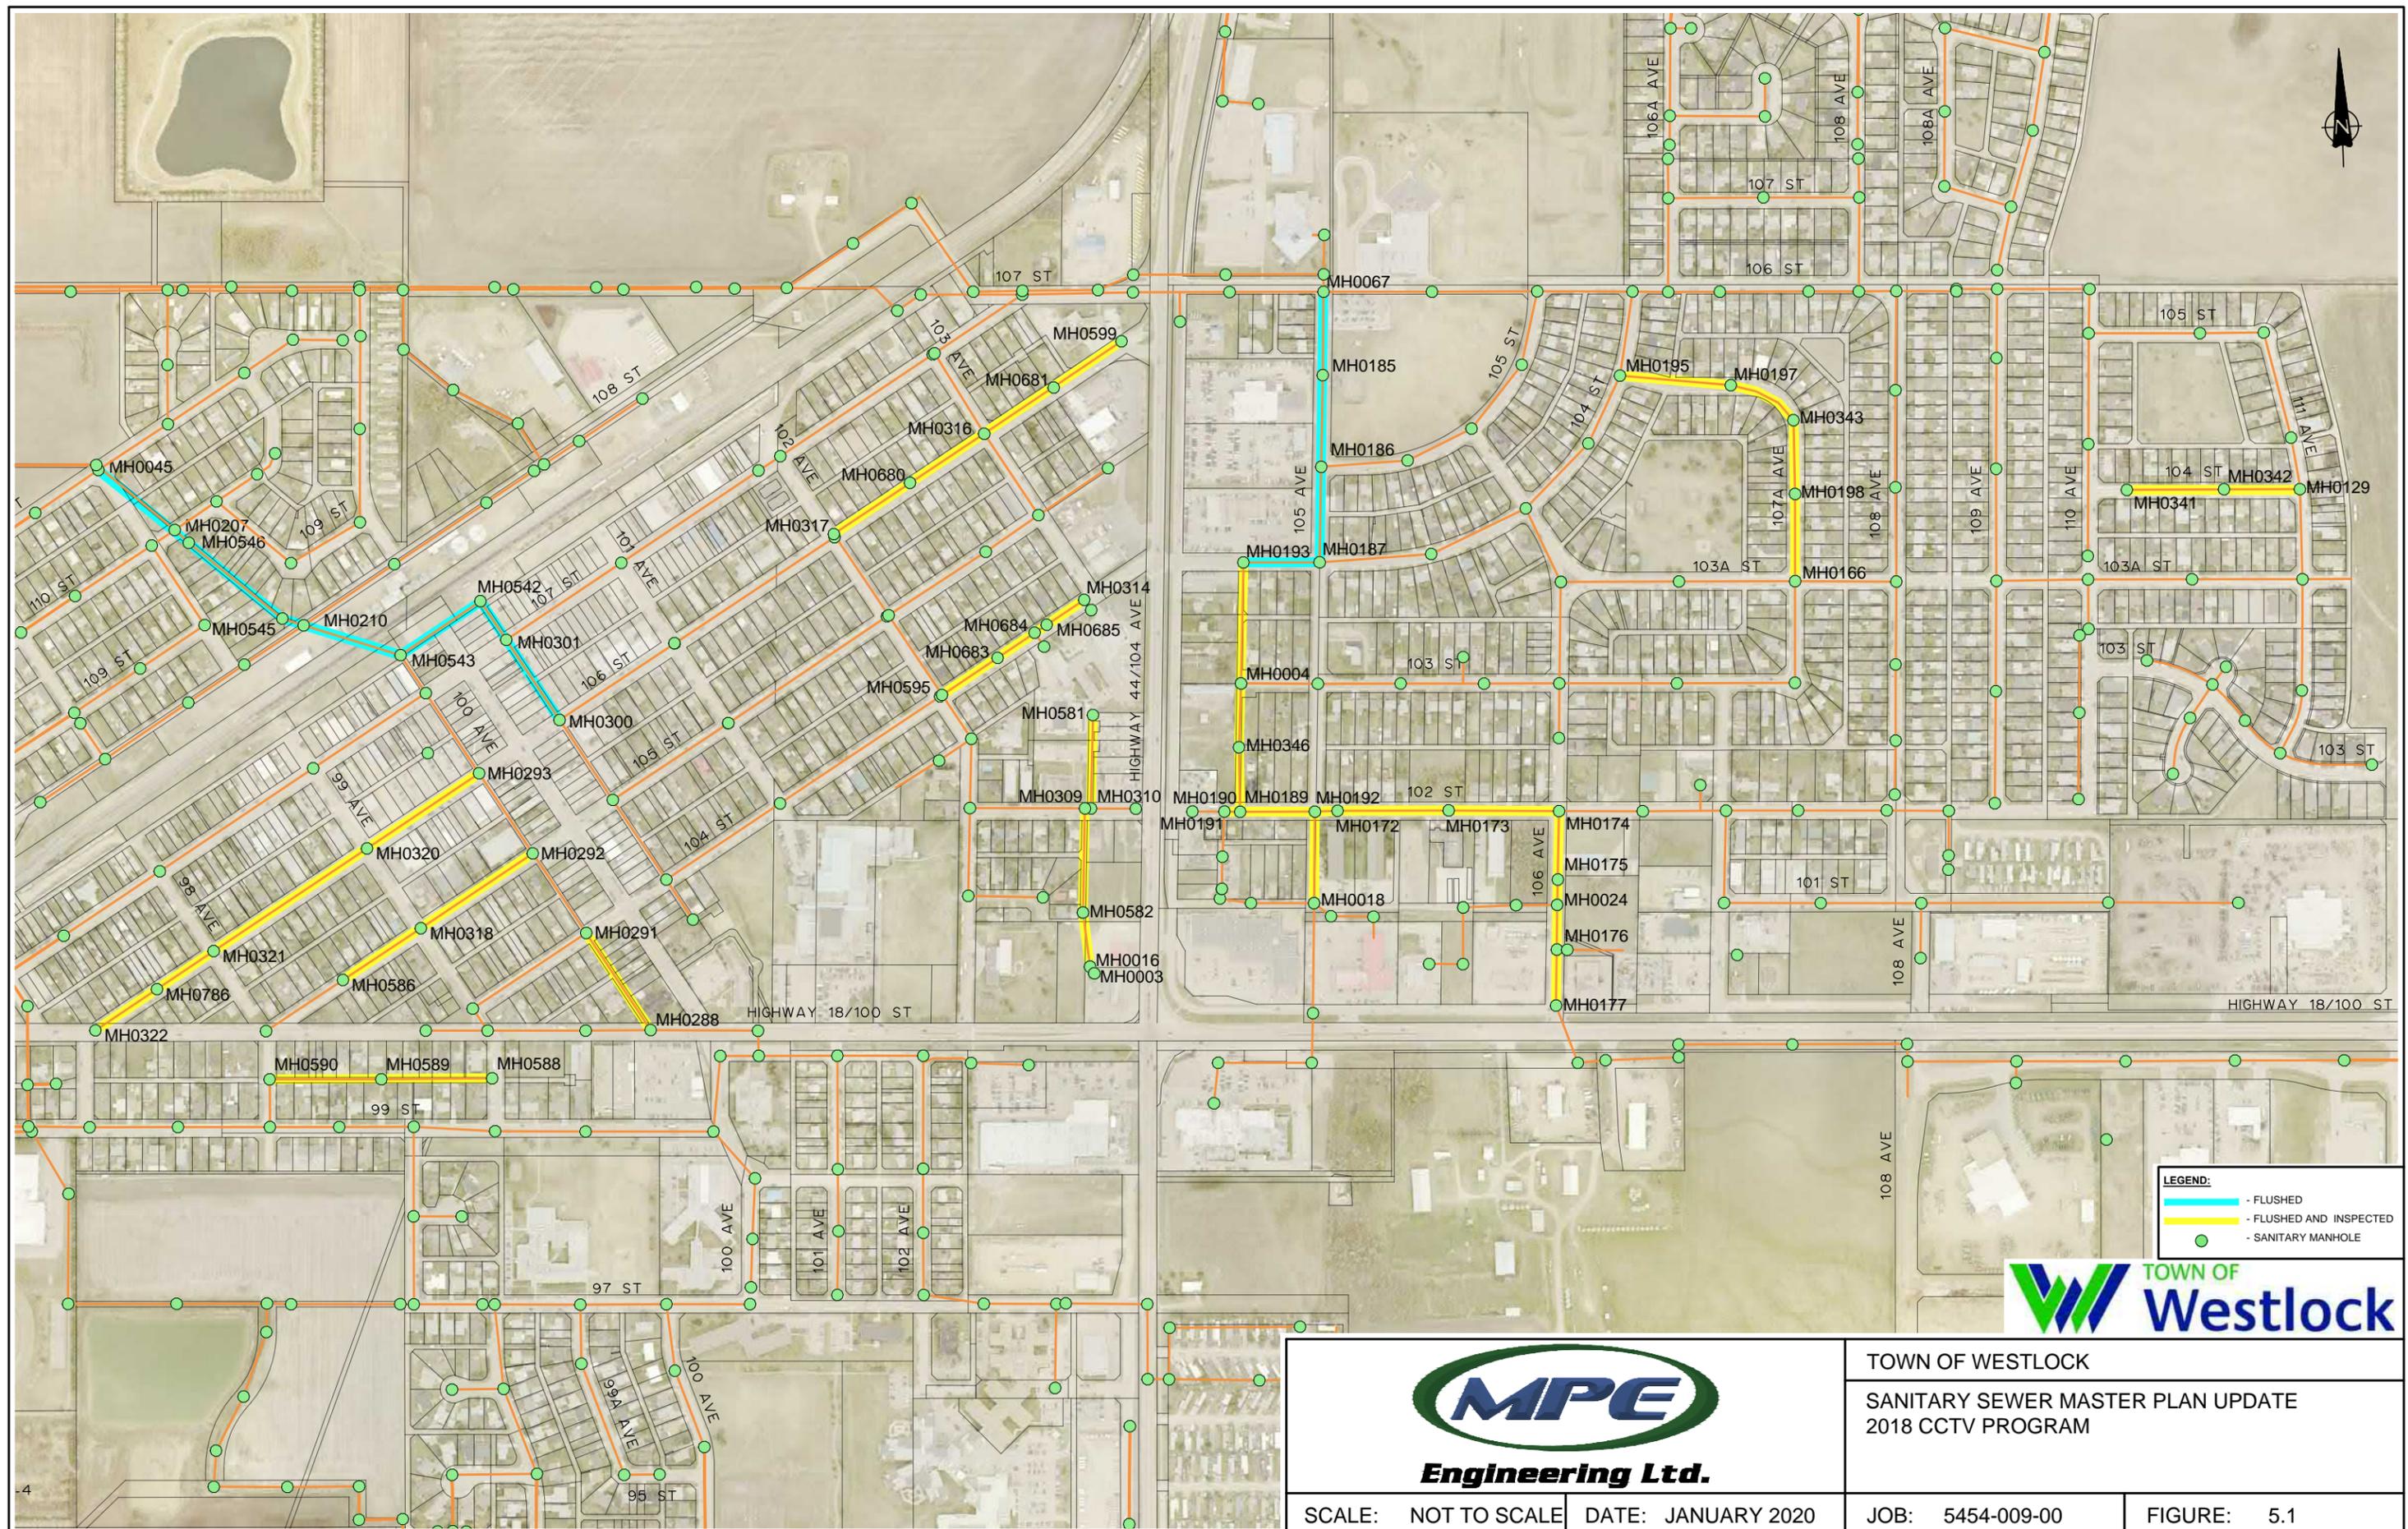
Cam-Trac reported that the section between MH0045 and MH0300 had high water and heavy debris during flushing. Additional flushing and cleaning is required along this line to complete a proper inspection. MPE recommends that the Town complete additional flushing and cleaning along this section so that it can be inspected.

Cam-Trac also reported high flows in the section between MH0193 and MH0067. The camera was under water for 60% to 70% of the inspection of this section during flushing and cleaning. This section was not inspected due to high flows. The high flows correspond to flows being above the capacity of the sanitary sewer main in the Flow Monitoring Report. This confirms the recommendation that the Town upgrade and install new sewers along 105 Avenue and 102 Street to reduce the hydraulic loading in the area and accommodate additional development in the East Business Park.

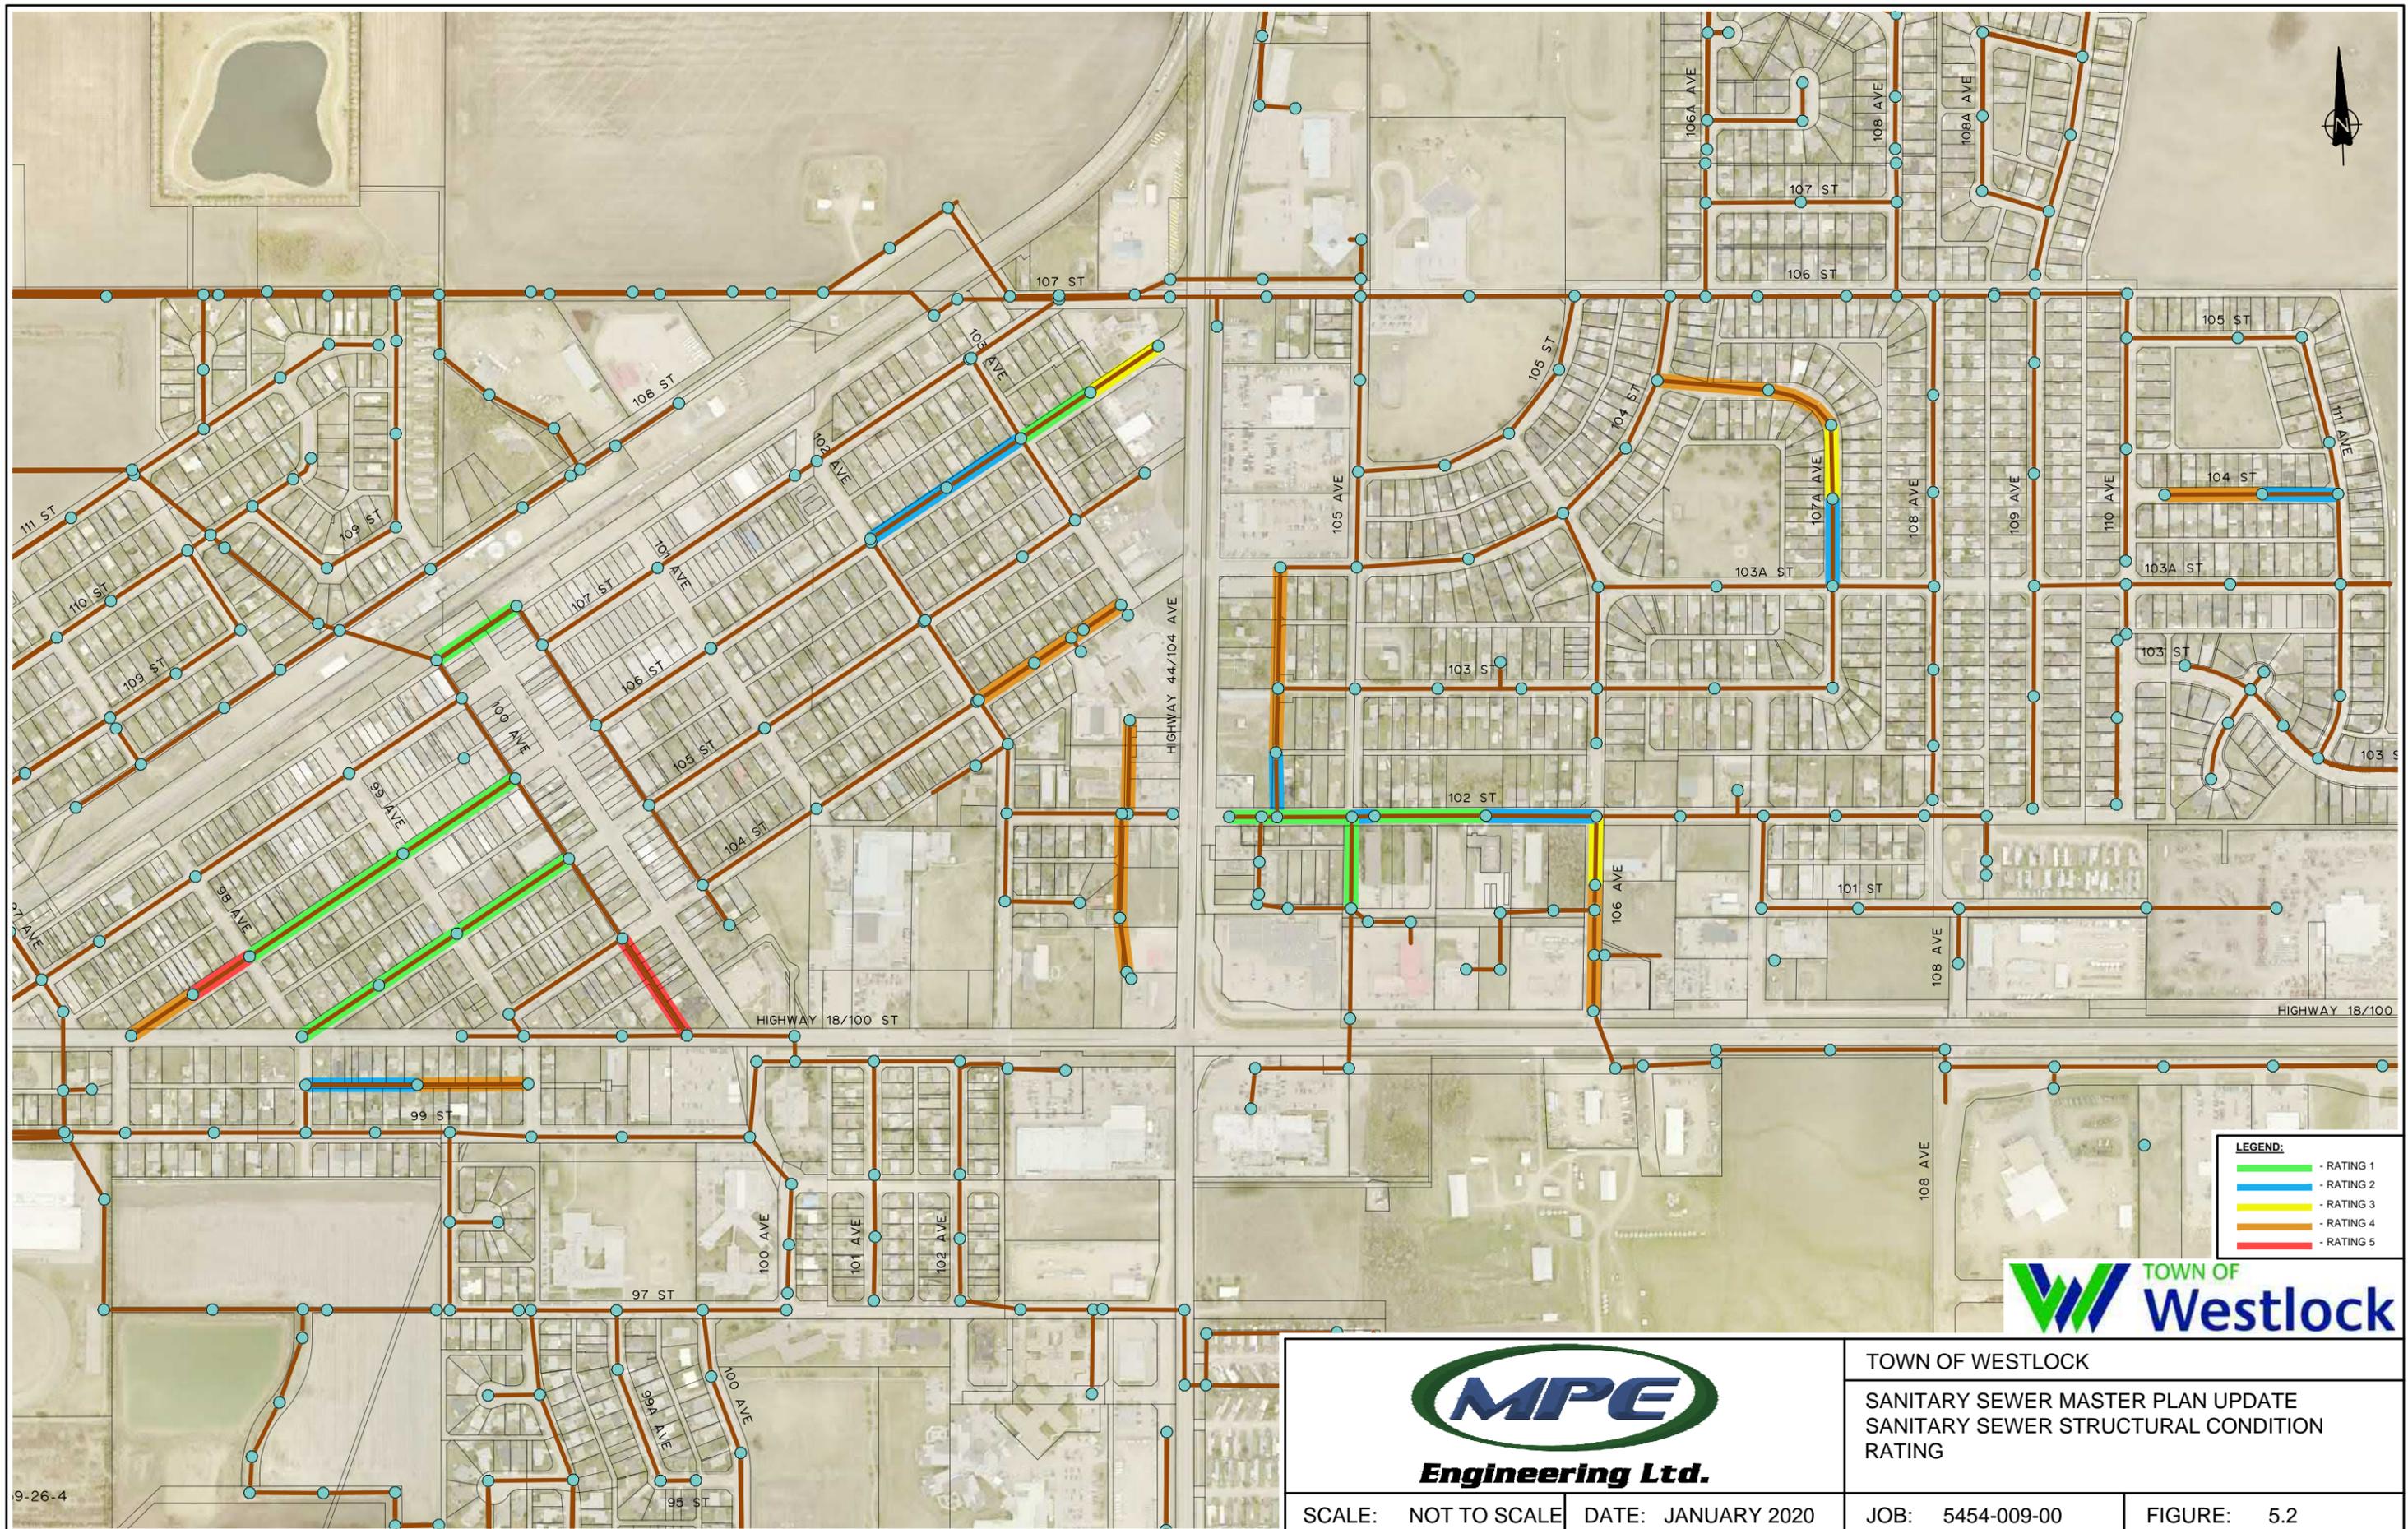
TOWN OF WESTLOCK
 SANITARY SEWER MASTER PLAN UPDATE
 SANITARY SEWER STRUCTURAL CONDITION
 RATING

A summary of the scores and condition ratings for each sanitary sewer section is provided in **Table 5.1**. The structural condition ratings for each section of sanitary sewer main are shown in **Figure 5.2**. A rating of 5 means that the sanitary sewer section is in poor structural or O&M condition. A rating of 1 means that the sanitary sewer is in good structural or O&M condition.

Table 5.1 and **Figure 5.2** show the majority of sanitary sewer mains inspected by CCTV have a structural condition rating of 4. There are two sanitary sewer mains with structural condition ratings of 5:

MPE recommends that sanitary sewer mains receiving a structural condition rating of 5 be the first priority for structural condition rehabilitation. We understand that the Town rehabilitated the sanitary sewer main between MH0291 and MH0288. MPE recommends that sanitary sewer mains receiving a structural condition rating of 4 be the second priority for structural condition rehabilitation. As part of the Town's ongoing operation and maintenance program, MPE recommends that sanitary sewer mains receiving a structural condition rating of 3 or less have their condition monitored.

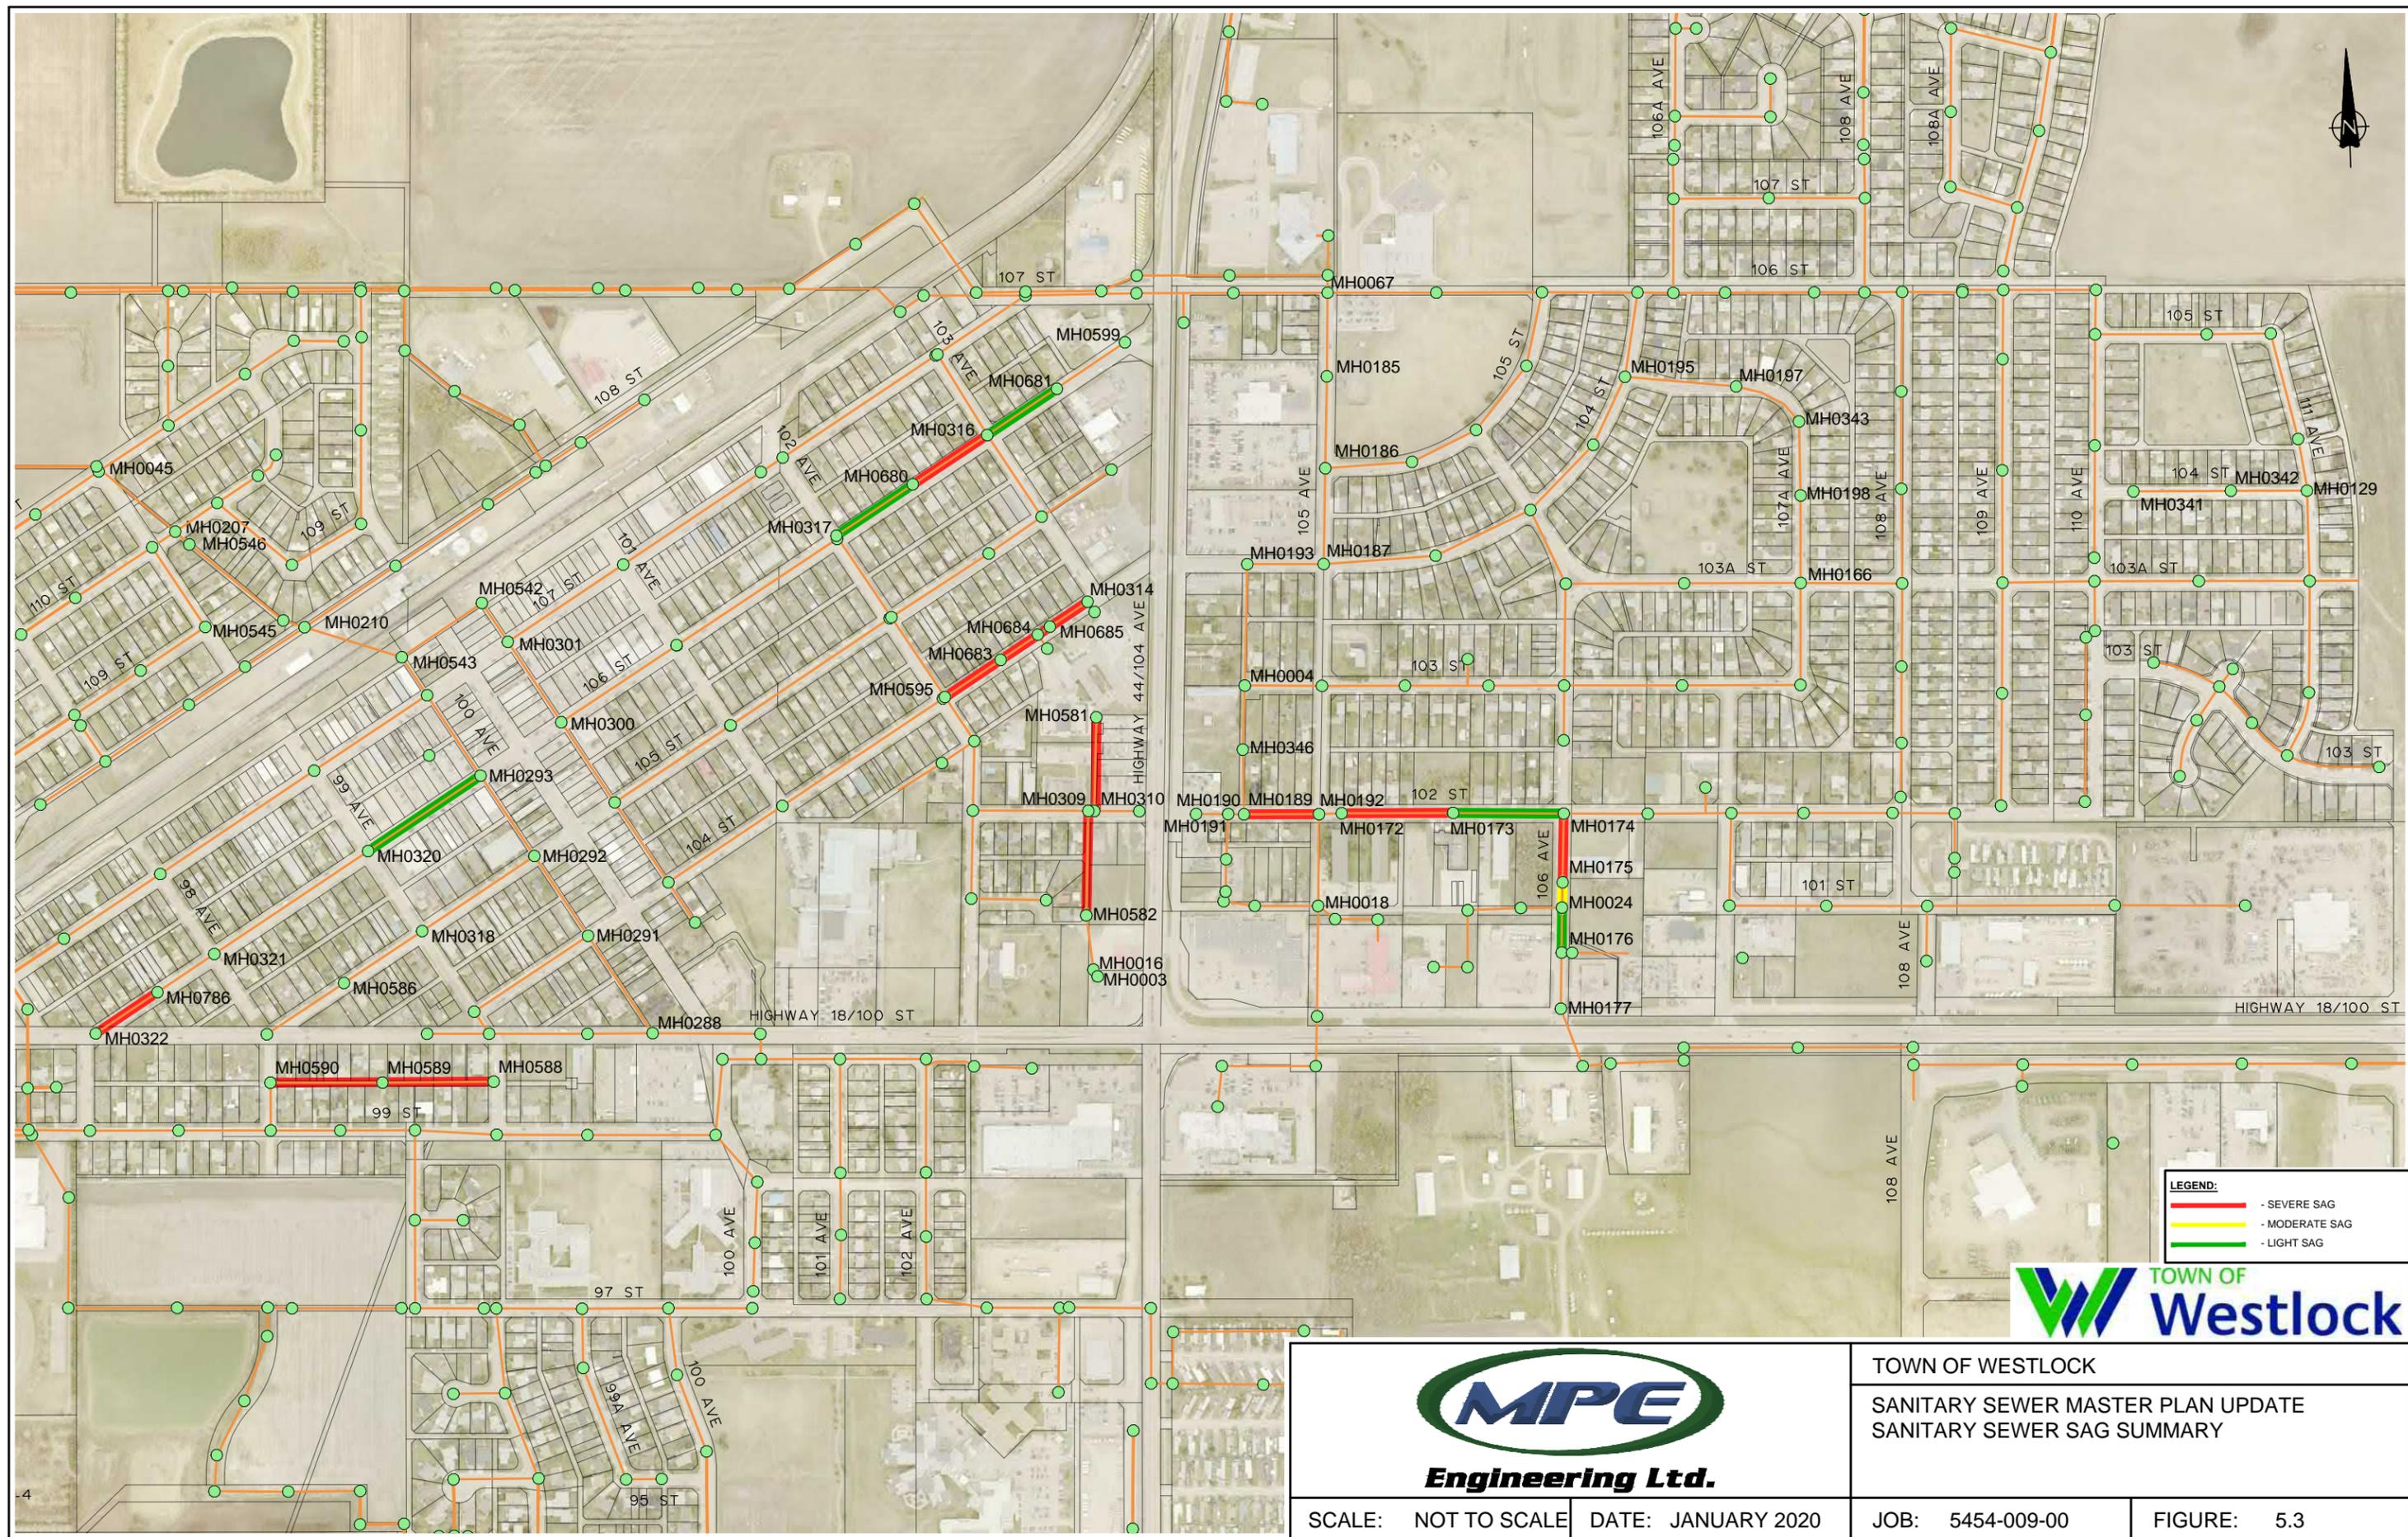
While sags are not assigned a score in the PACP program, other rating systems assign scores for these defects. Severe sags occur when the camera is underwater, moderate sags occur when the camera is partially submerged, and light sags occur when the water level is below the camera level. A summary of the sags observed is provided in **Table 5.2** below and are shown in **Figure 5.3** on the following page. MPE will consider sections of sanitary sewer main with severe sags to be in poor structural condition, with a rating of 5, and will consider sections of sanitary sewer main with moderate sags to be in moderate structural condition, with a rating of 3.

From	To	Condition Rating	Sags
MH0309	MH0582	4	Light Sag, Severe Sag
MH0683	MH0595	4	Severe sag, 3 moderate sags
MH0176	MH0024	4	Multiple light sags
MH0314	MH0685	4	Severe sag
MH0024	MH0175	4	Moderate sag
MH0685	MH0684	4	Severe sag
MH0175	MH0174	3	Severe sag
MH0684	MH0683	4	Multiple Severe Sags
MH0174	MH0173	2	Multiple Light Sags
MH0173	MH0172	1	Multiple Light Sags, severe sag
MH0322	MH0786	4	Severe sag
MH0192	MH0190	1	Multiple Severe Sags
MH0310	MH0581	4	Multiple Severe Sags
MH0681	MH0316	1	Multiple light sags
MH0317	MH0680	2	Multiple light sags
MH0680	MH0316	2	Severe sag, light sag
MH0588	MH0589	4	Severe sag, light sag
MH0589	MH0590	2	Severe sag, multiple light sags
MH0320	MH0293	1	Multiple light sags

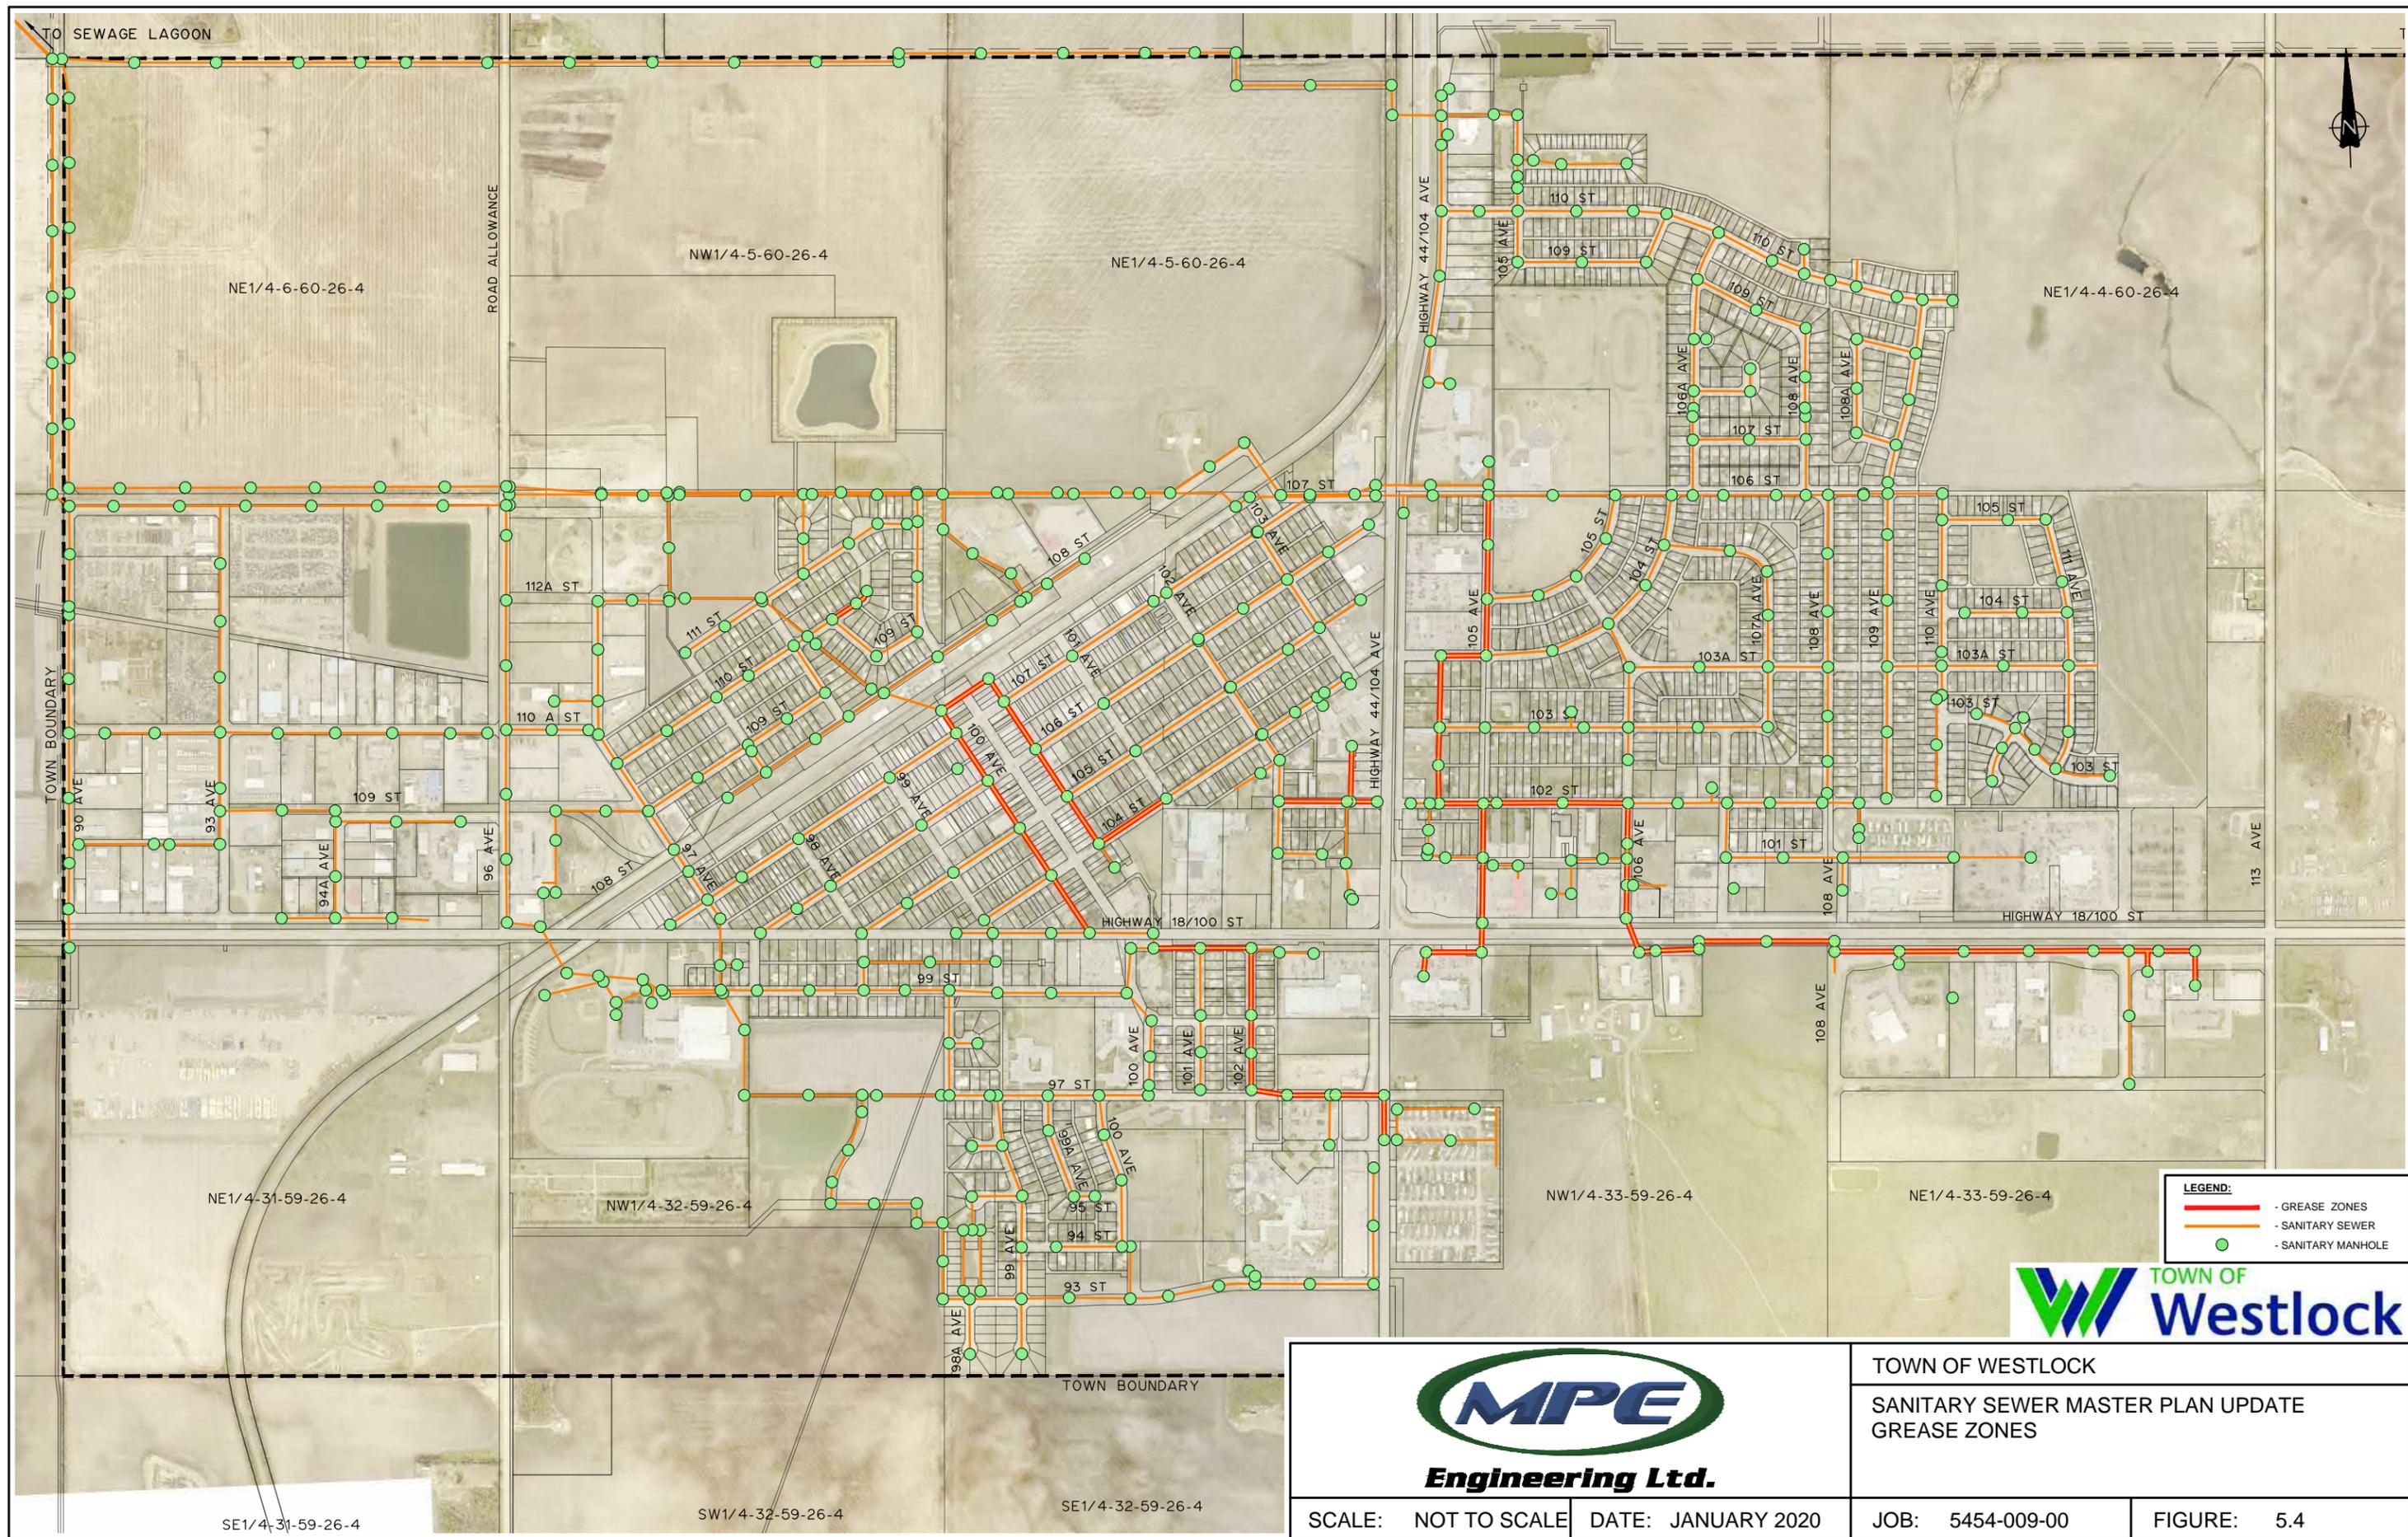
Figure 5.4 on the following page shows grease zones identified by Town staff. These zones correspond to two areas that were not inspected due to high flow and debris. The zones are in proximity to commercial areas. The trunk mains moving sewage north and west towards the wastewater treatment plant are considered grease zones. To remedy the grease zones, MPE recommends the Town inspect the grease traps in commercial businesses to determine if they are being cleaned by their owners and are working properly.

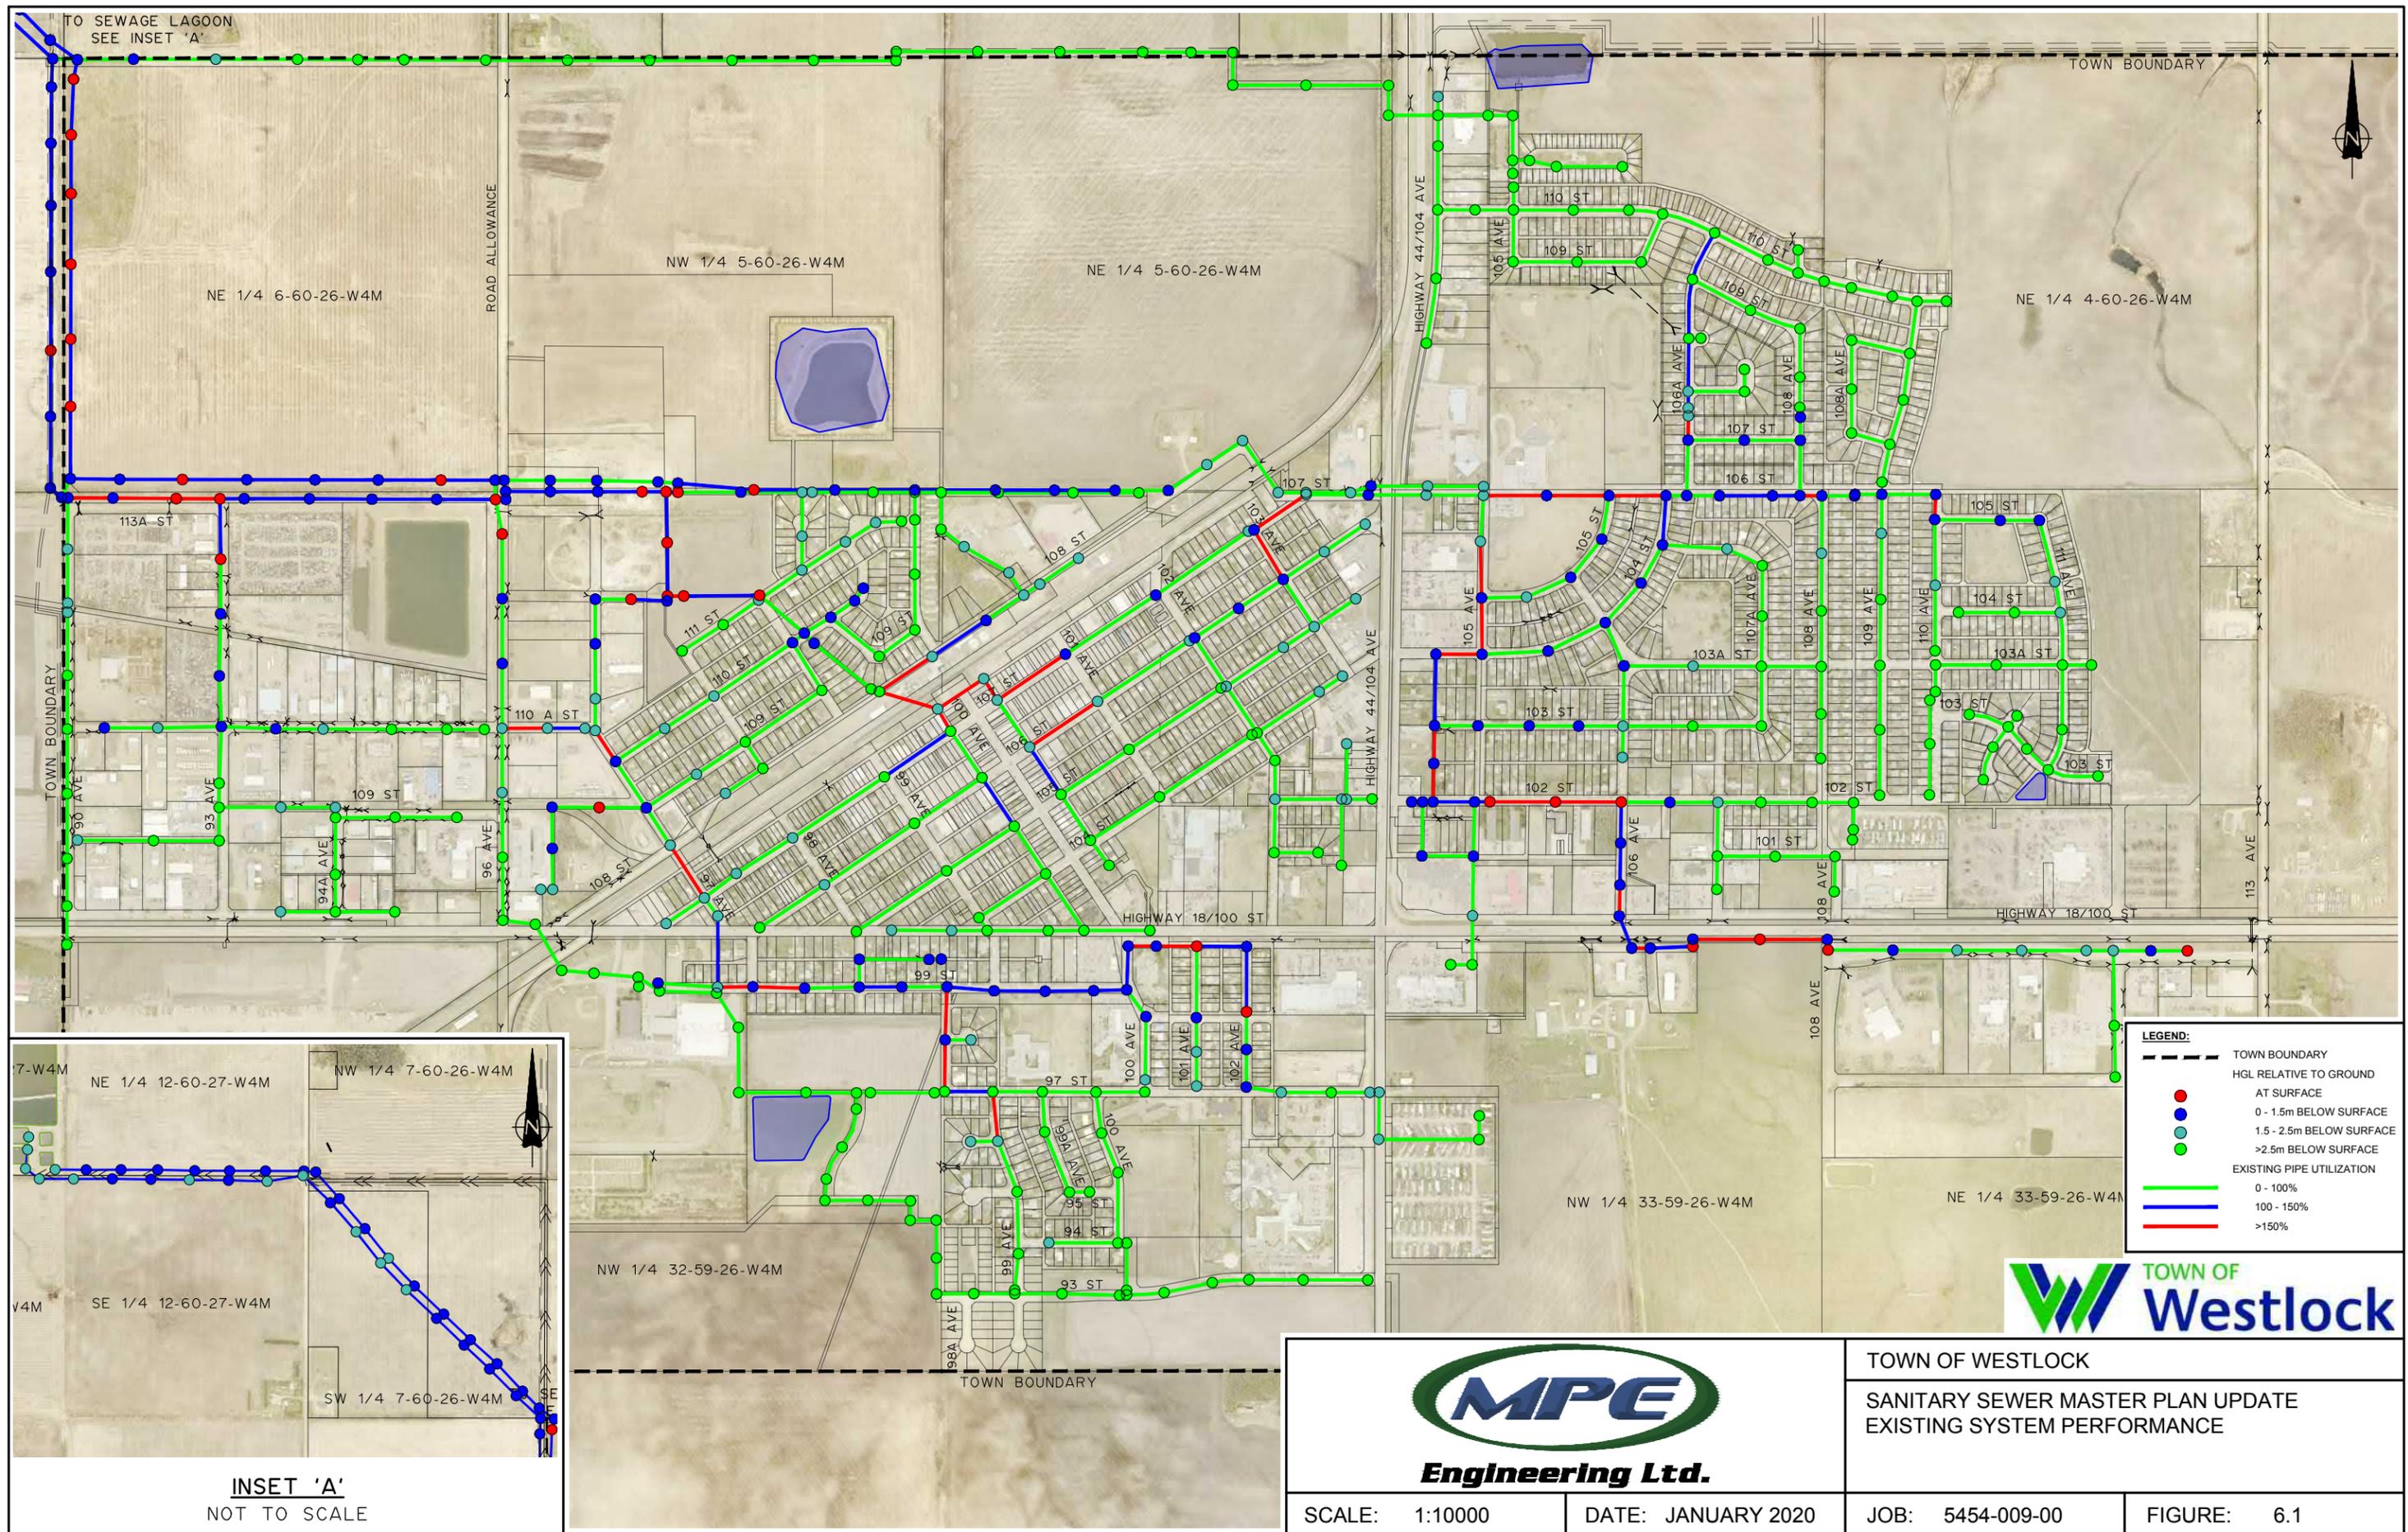
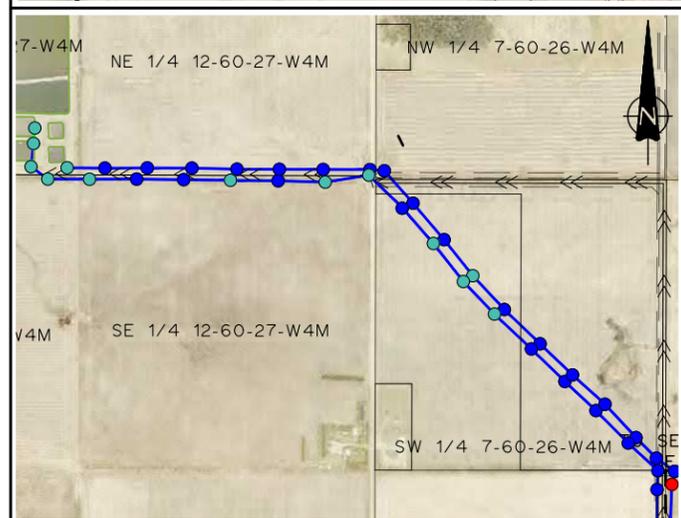
TOWN OF WESTLOCK
SANITARY SEWER MASTER PLAN UPDATE
EXISTING SYSTEM PERFORMANCE

The performance of the existing system is shown in **Figure 6.1**. The model review and verification found issues with system capacity in the downtown, East Business Park, and the industrial area.

As shown in **Figure 6.1**, there are situations where the existing pipe utilization is 0-100%, but the HGL is shown to be at the surface or 0 to 1.5 m below the surface. These are situations where a pipe is backed up due to high levels of infiltration during the peak of a storm event. This infiltration causes upstream manholes at lower elevations to surcharge due to temporary reverse flow. In these cases, the pipe downstream of the upstream manhole that is surcharging is not running beyond 100% flow capacity, it is just backing up.

The model review and verification found that central Westlock, the East Business Park, and the industrial area have capacity issues. The large storm event of August 2016 caused significant inflow and infiltration into the sanitary sewer system in the industrial area. The Flow Monitoring Report showed that other storm events resulted in significant inflow and infiltration contributions in this area.
