# **TOWN OF WESTLOCK**

## **Transportation Master Plan Update**

Date: December 09, 2019

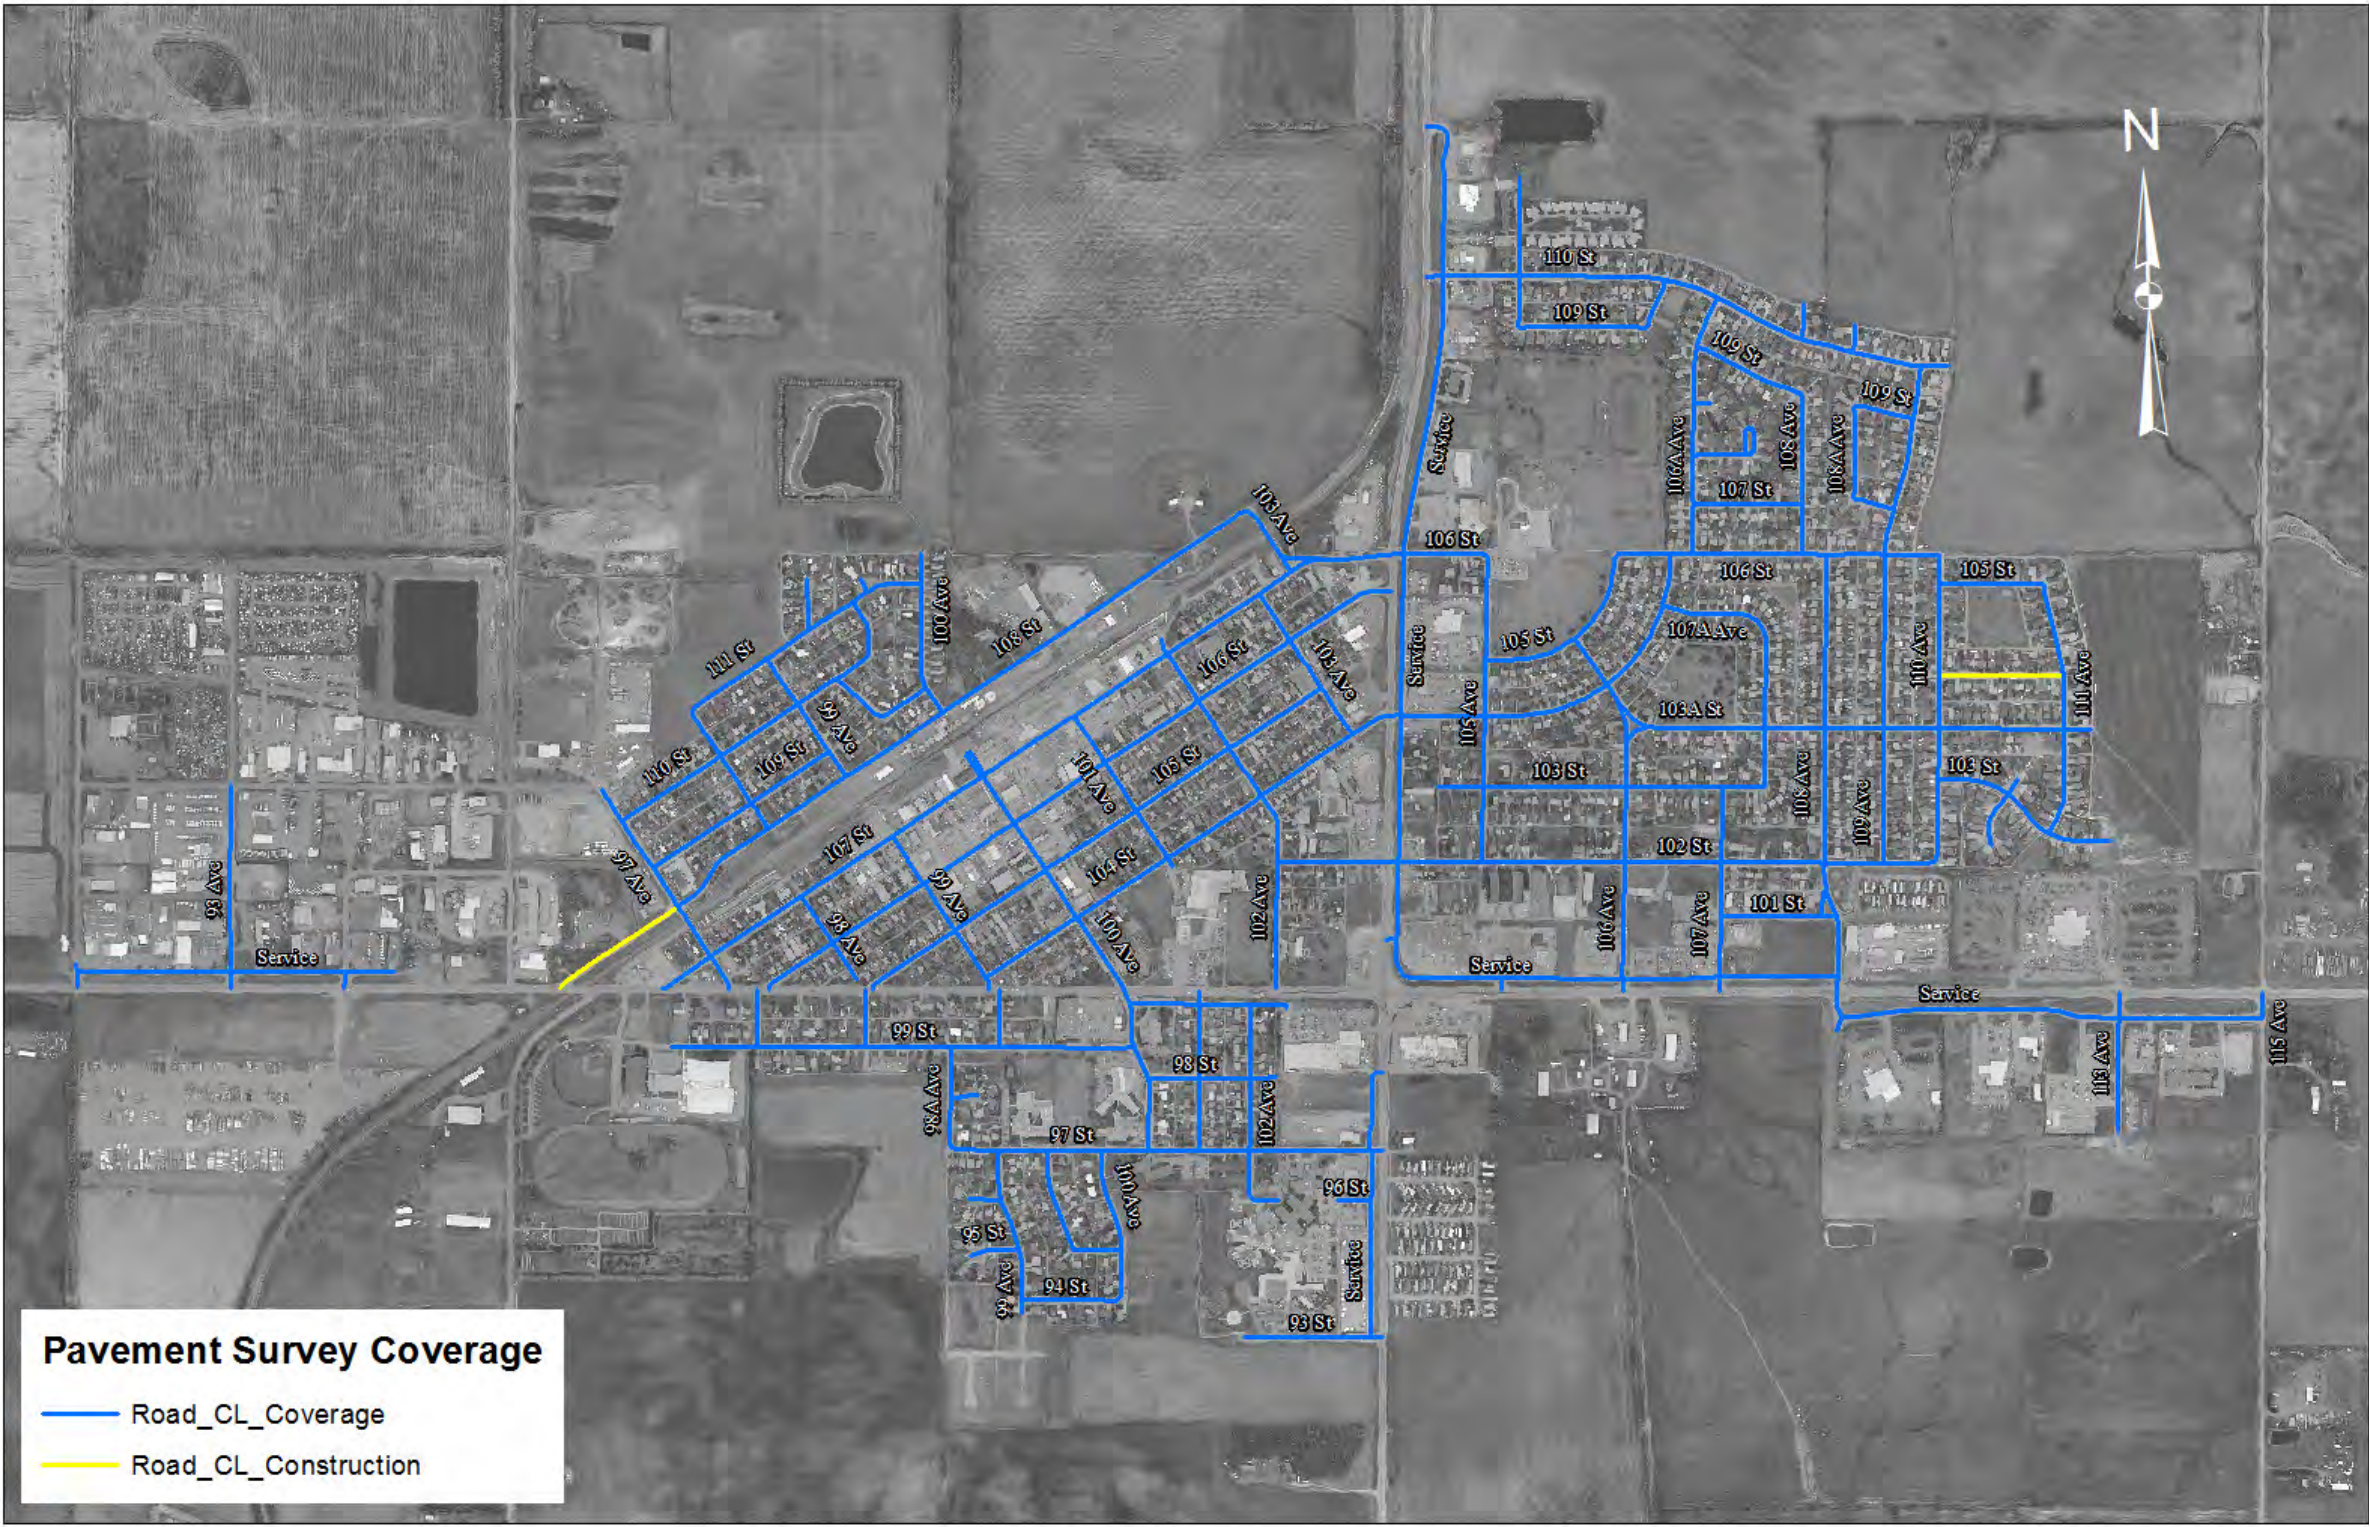
Figure E1: Pavement Survey Coverage - 2019

The analysis of the collected condition data indicates the majority of the Town's network is providing a marginal level of service given the network average OCI is 48 and the 2019 needs backlog is 57.7%. Due to the marginal performance of the network, the backlog is well above the range of 10%–25%, traditionally considered a healthy backlog. The roughness and structural capacity indicators in the network are showing the most deterioration.

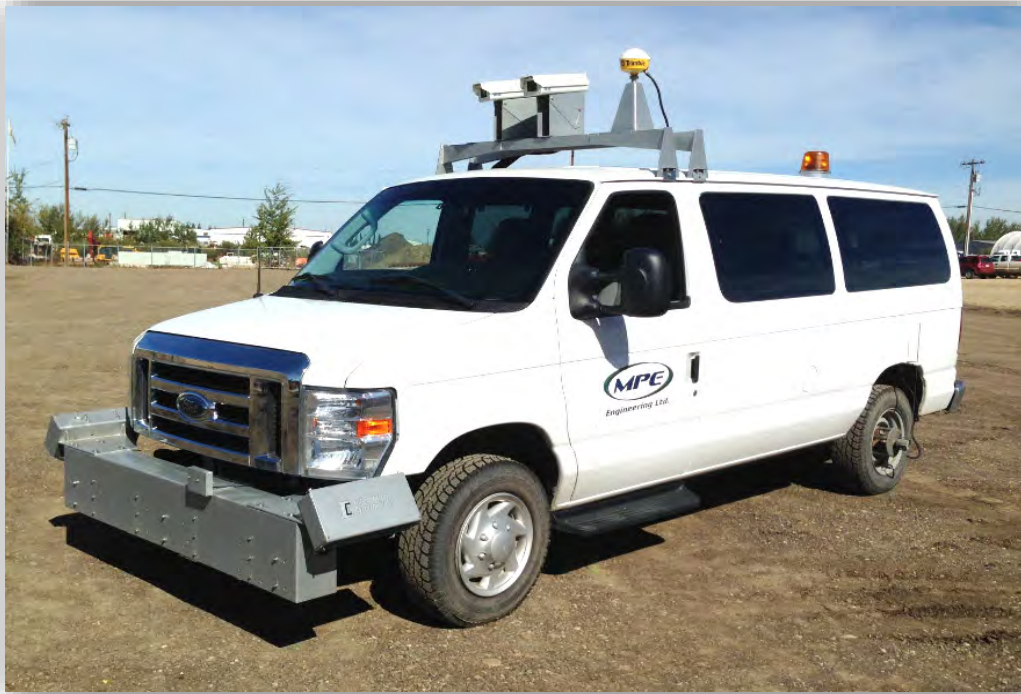
***MPE Engineering Ltd. Data Collection Vehicle (Class I Profiler)***

The following images show MPE's mobile road testing equipment and West Coast Road Testing's (WCRT) FWD/GPR equipment used for the pavement data collection.

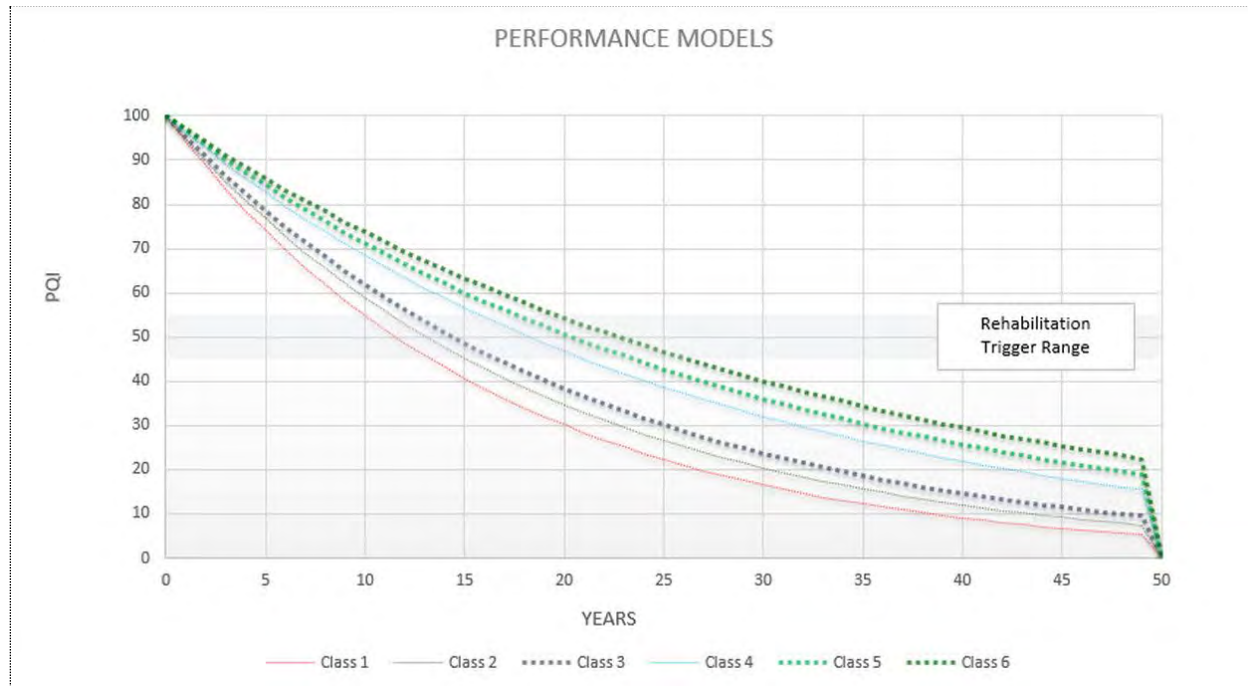
The OCI performance deterioration models used for the Town are shown in **Figure 3.1**.

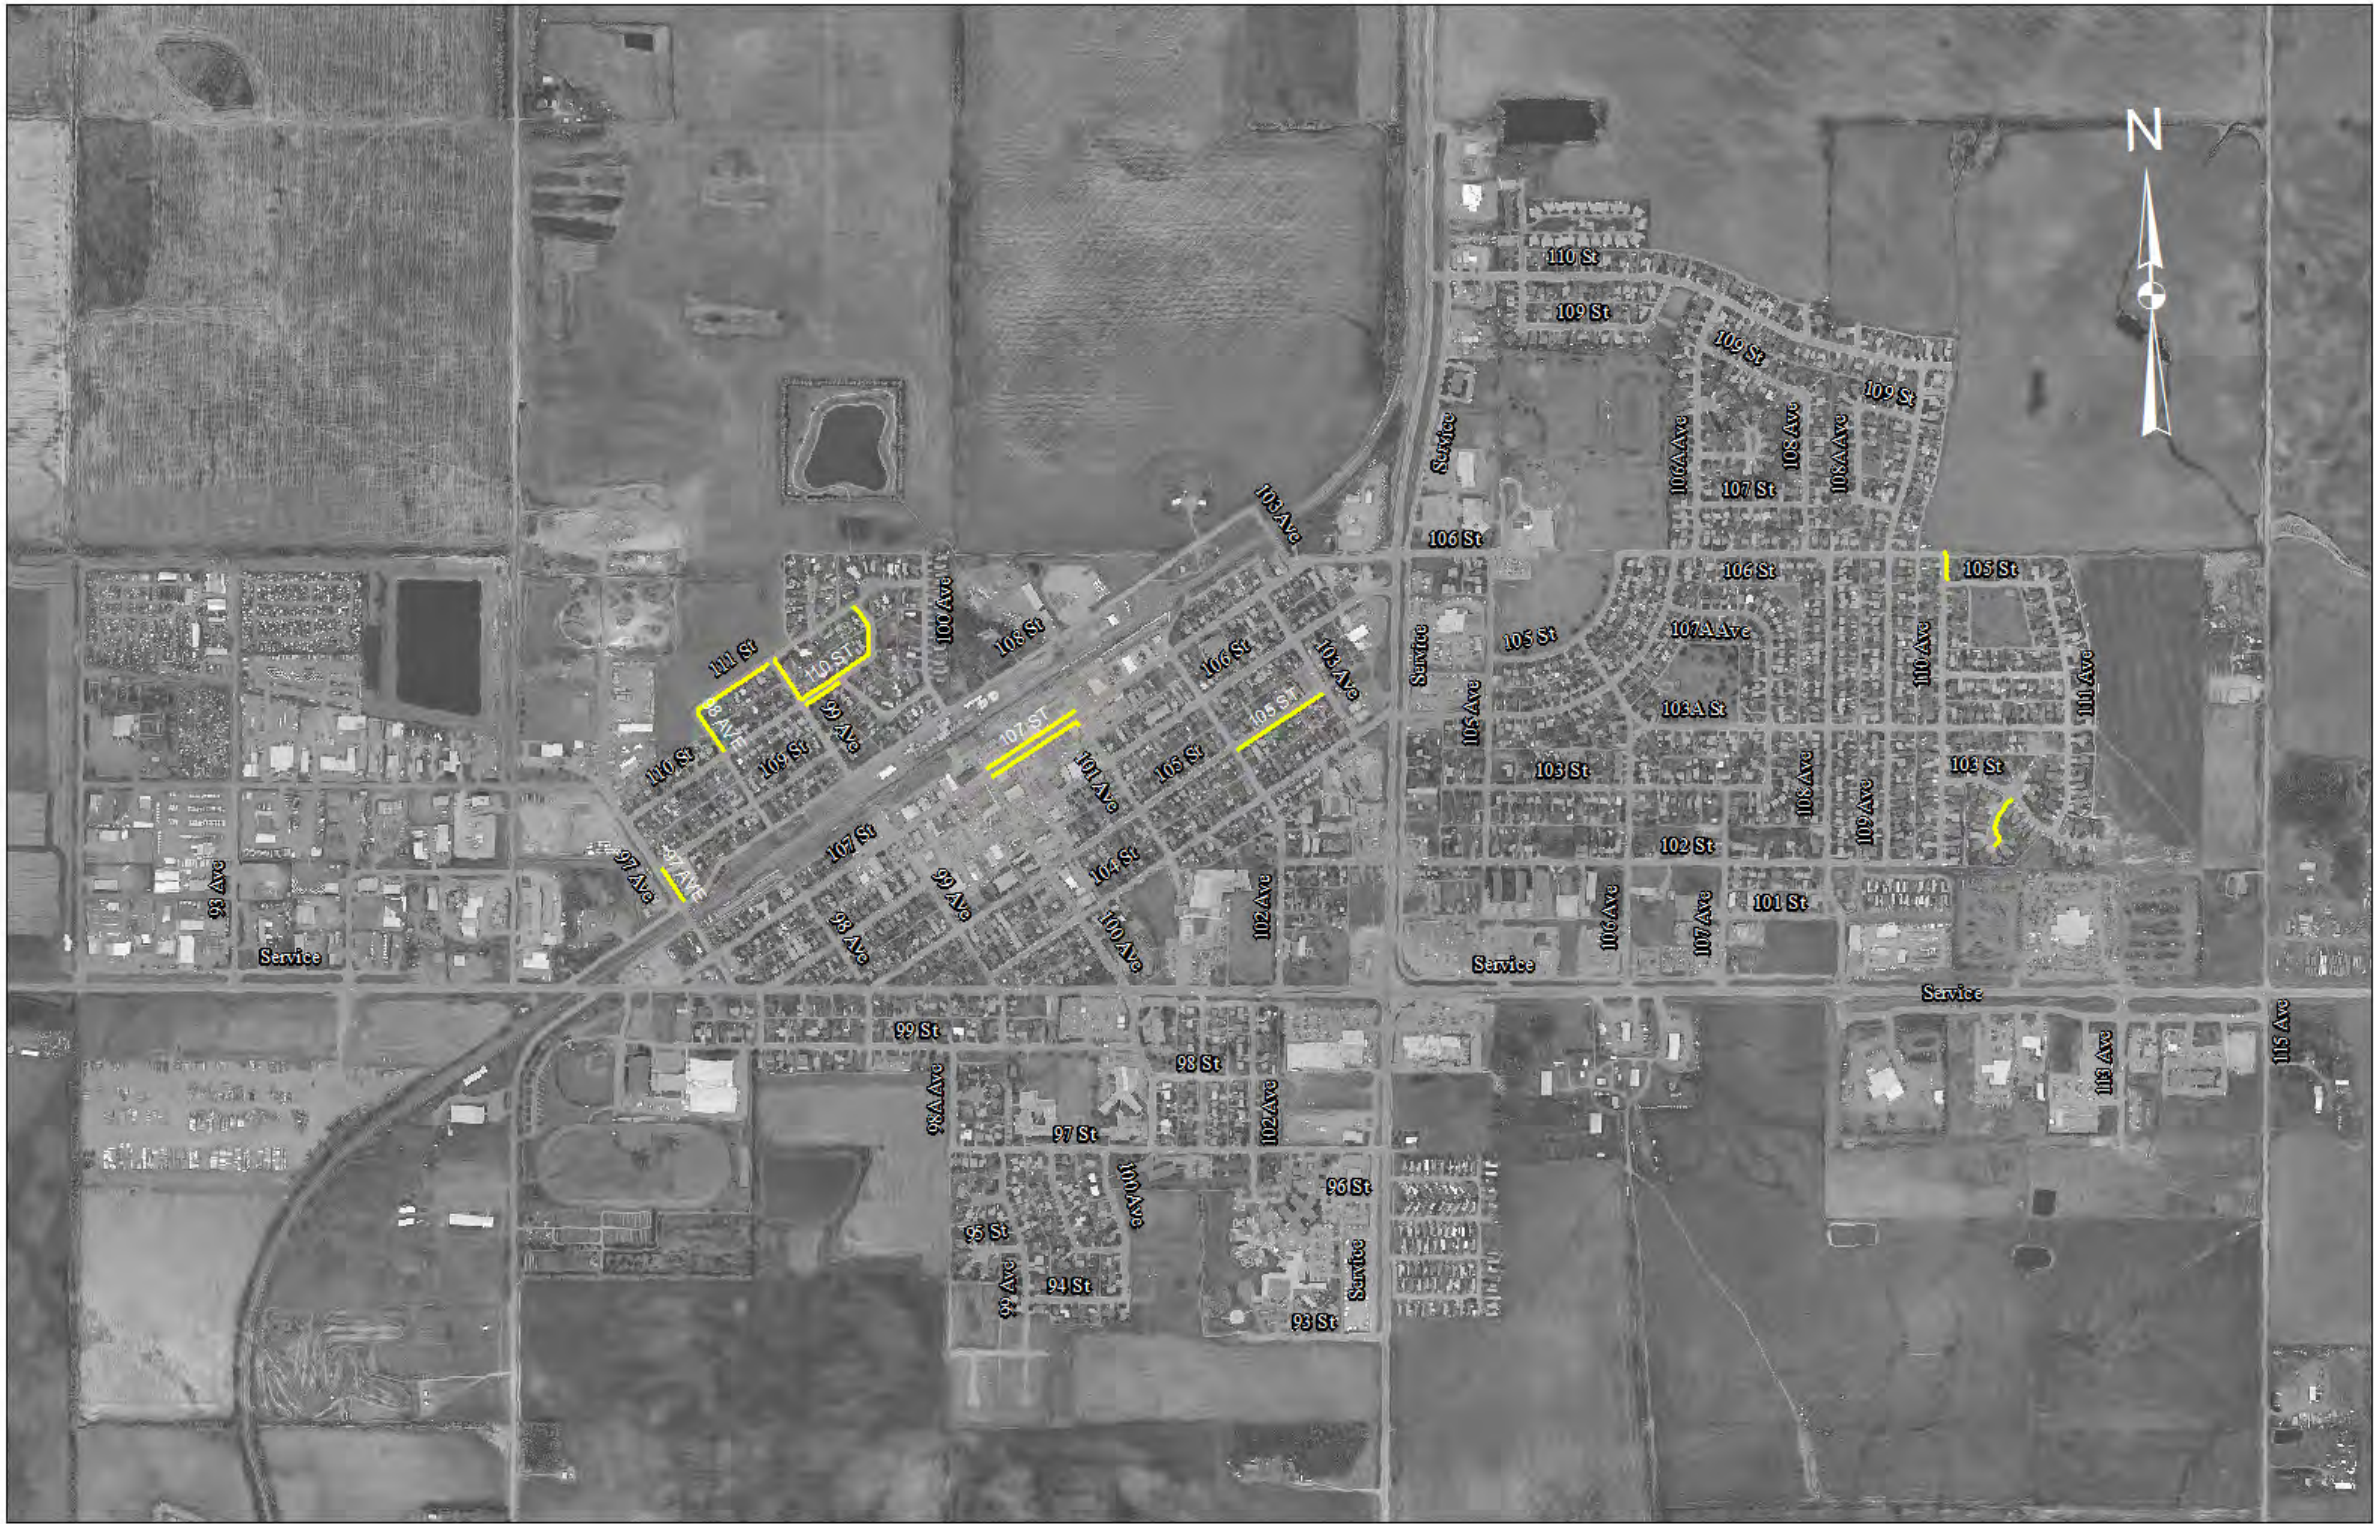
Figure 7.1c: Top Priorities Map - Sidewalk Network

A review of the segment results indicates that approximately 1.5 km of the network have a high priority for maintenance requiring an estimated \$310,475.00 in treatment costs, the majority of which are reconstruction costs. **Figure 7.1c** on the following page displays the high priority segments.
